# Agricultural Tile Drains Clogged With Cover Crop Roots?

Eileen Kladviko, Purdue University  
Barry Fisher, Natural Resources Conservation Service  
Larry Brown, The Ohio State University  
Created: June 2016

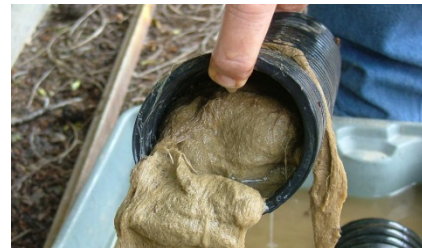
Roots and sediment clogging tile drain.

Other agricultural advisers were hearing similar stories and many were posting and reading about these reports online. The reports suggested that cover crop roots were to blame and some had photos showing roots and sediment blocking short sections of tile drains.

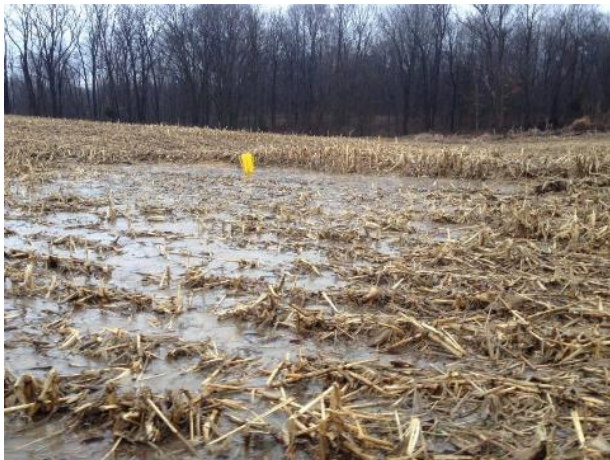
Surface riser in depression, with potential for residues and sediment to enter tile drain system through surface runoff.

There are several factors related to tile systems that might contribute to the potential for clogging by roots. Tile risers are often placed in low spots in the field, which allow ponded water to drain through the riser and into the tile system more quickly than would occur if all the water had to infiltrate the soil. The holes on the risers are relatively large, which can permit not only water but also residues and other debris to pass through and enter the tile.

For surface risers, consider installing a filter or sock on the riser to reduce the potential for residue and sediment from entering. Or, consider replacing the riser with a blind inlet. Blind inlets filter sediment and phosphorus from a low spot while still allowing the depression to drain

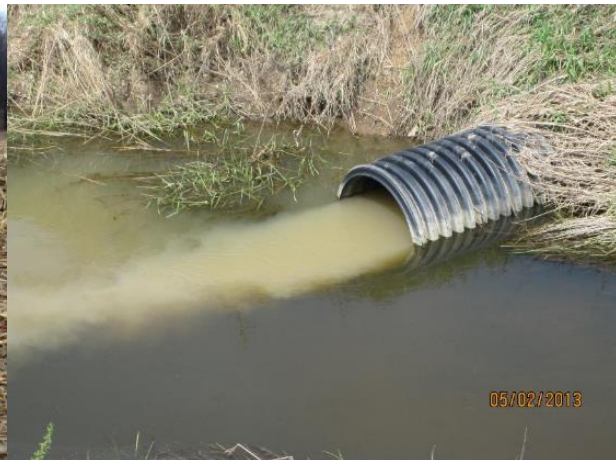
Sediment exiting tile, likely originating from surface riser.

With the rising popularity of vertical tillage and similar practices that “size” the residue into smaller pieces, more residue is moving with surface runoff, and these particles could enter risers. As such, residues and sediment have the potential to accumulate in the tile, partially restricting flow and providing nutrients and an attractive environment for any roots (if they are present) to proliferate.

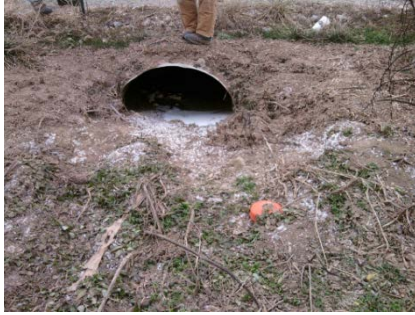
Surface riser nearly buried by sediment and debris near roadside culvert.

The frequency and intensity of rainfall in spring and early summer 2015 may have contributed to a greater than usual accumulation of residues and sediments in fields with risers. Some risers have been found that were nearly covered with sediment and debris and are obvious sources for materials to get in and clog a drain.

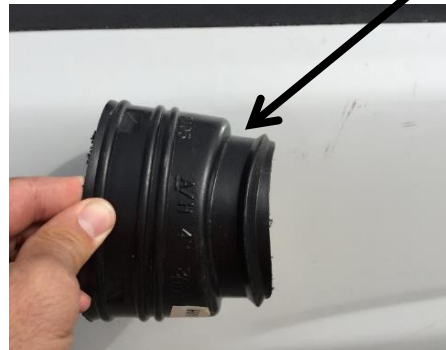
Internal coupler for drain tubes.

This channel width and lip are manufactured to minimize intrusion into the flow.

Internal couplers, used where laterals are connected to mains or submains within the drainage system, may serve to catch residue or other debris. Lateral tile can also be inserted into the main drain simply by cutting the main and inserting the lateral (sometimes further than necessary), but this is not an approved method of making connections. The amount of debris may grow larger as more debris is caught, eventually restricting drain flow. External couplers are a better alternative to making connections as they provide little if any internal restriction from the connection. Internal couplers are easier to install while contributing to potential blocking problems as described above. External couplers are a little more difficult to install, but may alleviate the problems with flow obstruction.

Consider using taped external couplers for tile junctions rather than internal couplings. This practice could reduce the potential internal restrictions that may trap residues and sediment that roots find attractive. If you use internal couplers, be sure to trim any excess that could extend into the main and capture sediment.

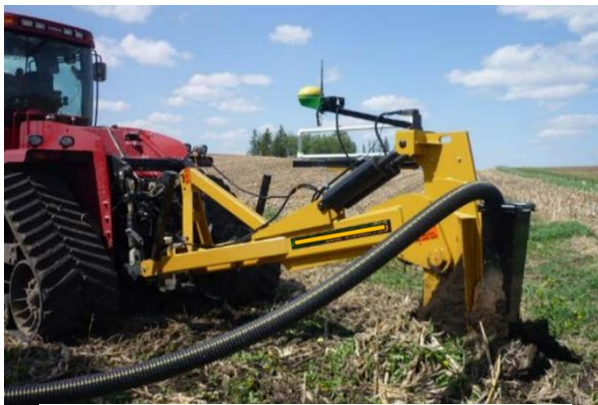
Drainage plow installing drain tubing in field.

Although installers aim to carefully control the grade of the tile, it is nearly impossible to have perfect installation of every foot of tile, especially on difficult, undulating landscapes, uneven soil surfaces, very dense subsoils, and subsoils with stones or rocks. ASTM standards allow slight deviations in pipe installation grade, but these are limited. Additionally considering the increase in use of self-propelled drainage plows, and tractor pulled plows, drainage systems are installed faster than with trenchers. ASTM standards specify plow speed limits.
