Agricultural Tile Drains Clogged With Cover Crop Roots?

Eileen Kladviko, Purdue University
Barry Fisher, Natural Resources Conservation Service
Larry Brown, The Ohio State University
Created: June 2016

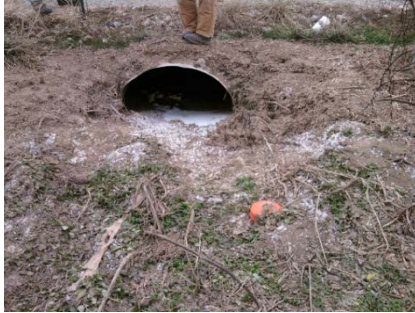
Surface riser nearly buried by sediment and debris near roadside culvert.

The frequency and intensity of rainfall in spring and early summer 2015 may have contributed to a greater than usual accumulation of residues and sediments in fields with risers. Some risers have been found that were nearly covered with sediment and debris and are obvious sources for materials to get in and clog a drain.
